SR 7 Route Development Plan (Phase 1)

Stakeholder Committee Meeting Summary

Meeting Date: September 29, 2005

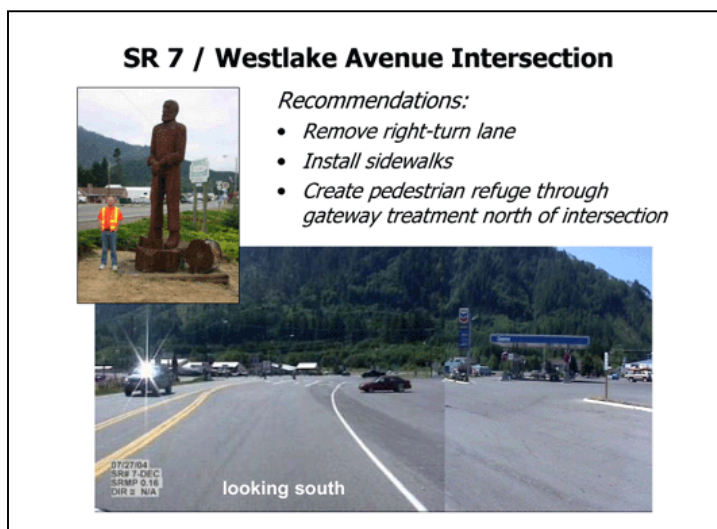
At the intersection of Westlake Avenue and SR 7, three problems were identified:

1. The highway is extraordinarily wide, with 45 feet of paved surface to the west of the fog line and the curb delineating the corner of the Chevron Station property, making it difficult for pedestrians to cross.
2. Lane delineation that has been identified by the community as confusing, especially during snowy conditions. It is especially difficult to tell where southbound vehicles should be queuing to turn right at Westlake due to the wide paved surface.

3. Poor access control in the northwest quadrant of the intersection (by the Chevron Station), making turning movements unpredictable.

Construct curbs and sidewalks, leaving an eight-foot shoulder (consistent with current shoulder widths at this location) on the west side of SR 7. Traffic analysis has determined that the southbound right turn lane is unnecessary to maintain an acceptable level of service, and could be removed to narrow the roadway even further. This solution would make this segment of SR 7 easier for pedestrians to cross, help define the roadway, and provide better access control.

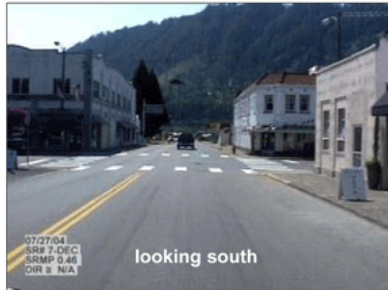
SR 7 / SR 508 – Davis Lake Road Intersection

With city agreement, recommend improving sight distance by extending loading zone curb markings in NW quadrant

The solution at this location improves sight distance by increasing the loading zone curb markings in the northwest quadrant from the existing 26 feet to 76 feet. It would not help to extend the loading zone/no parking beyond the additional 50 feet, because the buildings obstruct the view at that point.

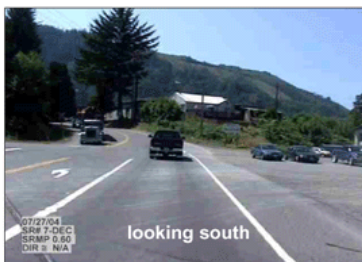
Sight distance impaired by high embankment and vertical and horizontal curves

Recommend reshaping embankment

Referring to the picture, Lynn explained that the sight distance at SR 7 and Fairhart Way was identified as a problem.

WSDOT's evaluation of this intersection found the sight distance at this location to be at or very near design manual standards. However, the steep grade approaching the intersection might reduce the margin of error compared to a more typical situation. Two things interfere with the line of sight at this location, the high bank along the roadway, and the steep, short horizontal and vertical curves approaching the intersection.

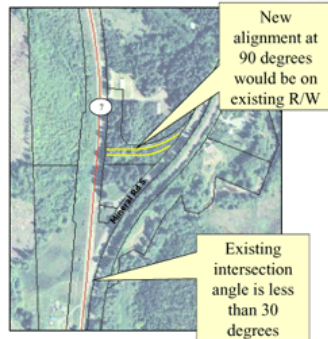
Mineral Road S. Intersection Milepost 11.66

Recommend relocate intersection to improve entry angle

New alignment at 90 degrees would be on existing R/W

Existing intersection angle is less than 30 degrees

Mineral Road South is the primary connection between the communities of Mineral and Morton. Mineral Road South meets SR 7 at an acute angle of less than 30°. There is a short cutoff road north of the intersection, which meets SR 7 at a 90° angle. North and southbound vehicles were observed using this cutoff in order to improve their sight distance. Therefore, we are recommending that the intersection angle be corrected to increase safety at this location.

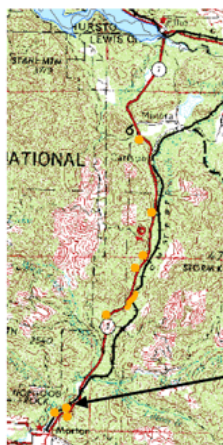
Milepost 1.9 West (800 ft section)

Outside of substandard curve
Inadequate recovery area/clear zone
Steep embankment to river

Recommend widen shoulder and install guardrail

Located on the west side of SR 7: Steep embankment to the river, outside of a substandard curve with inadequate recovery area and clear zone. This is the site of the 2003 fatality. Recommend widening the shoulder and installing guardrail.
